## **Demonstration of Antimicrobial Corrosion-Resisting Interior Coating Systems for Military Facilities in Warm, Humid Locations**

Final Report on Project F10-AR04

June 2017

Under   Project F10-AR04, "Application of New Corrosion-Resistant Mold Abatement  
Technologies for Interior Surfaces of Buildings at Fort Polk, LA"

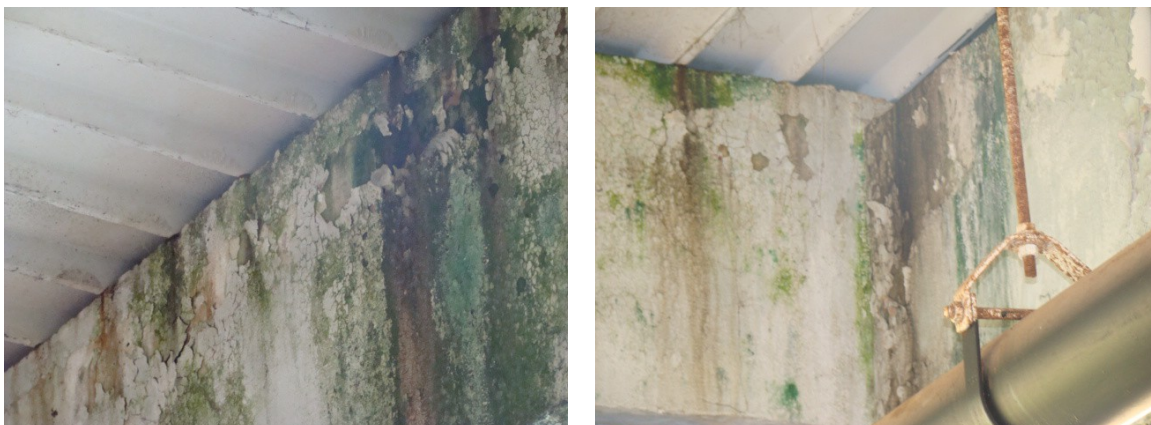
Figure 2. Mold in Fort Polk pumphouse with concrete block walls.

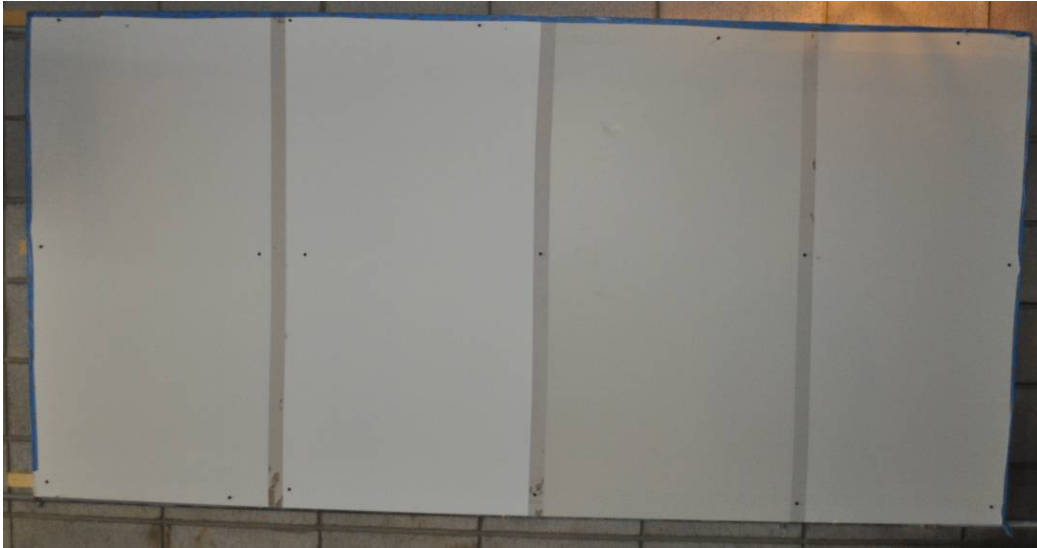
Figure 9. Test panels in the mechanical room after 4 months.

*Mechanical room test panels.* None of the test panels in the mechanical room showed any signs of mold or mildew in this inspection (Figure 9).

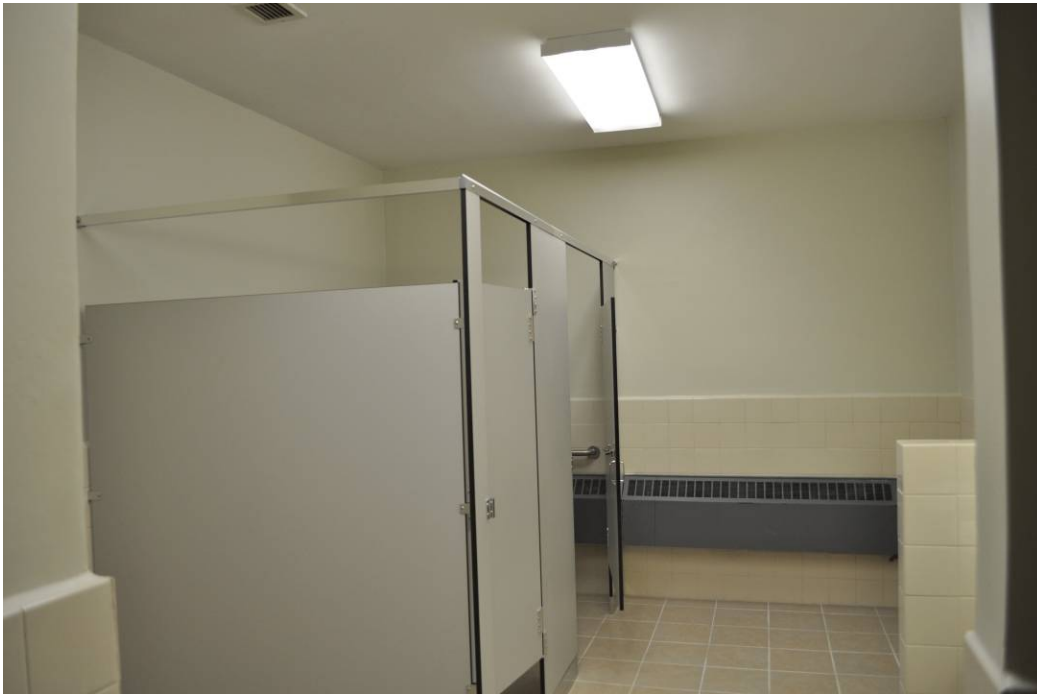
*Room 4 – Foster 40-20.* Noting the addition of a new HVAC system and repainting of most test surfaces, the inspection found no signs of mold or mildew on the ceiling. The repainted walls also showed no signs of mold or mildew (Figure 10 and Figure 11).

Figure 10. Walls in Room 4 coated with an unknown coating, and ceiling coated with Foster 40-20 after 4 months.

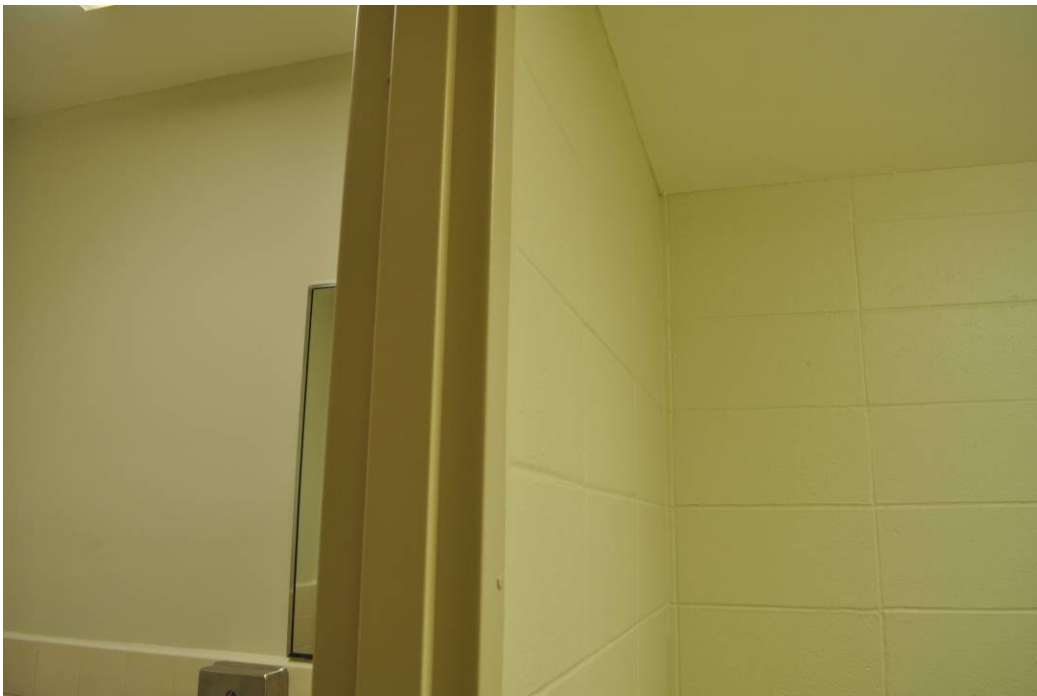
*Room 9 – Caliwel with BNA.* Under the conditions noted above, the washroom by Room 9 appeared to be unaffected by any mold or mildew growth (Figure 12 and Figure 13).

Figure 12. Washroom of Room 9 recoated with an unknown coating after 4 months.

Figure 13. Division of Room 9 with unknown coating in the washroom walls and Caliwel on the ceiling.

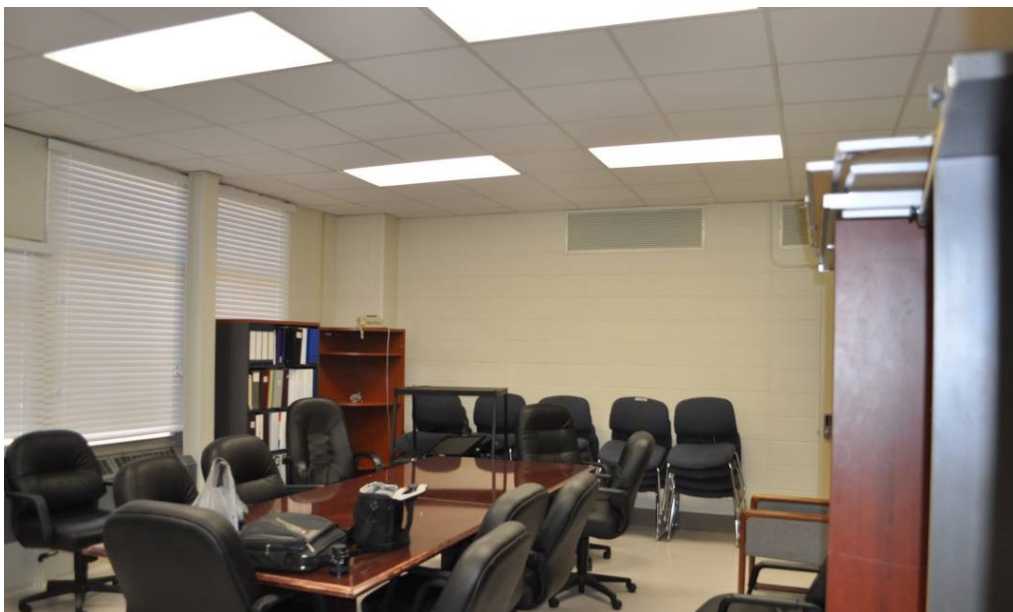
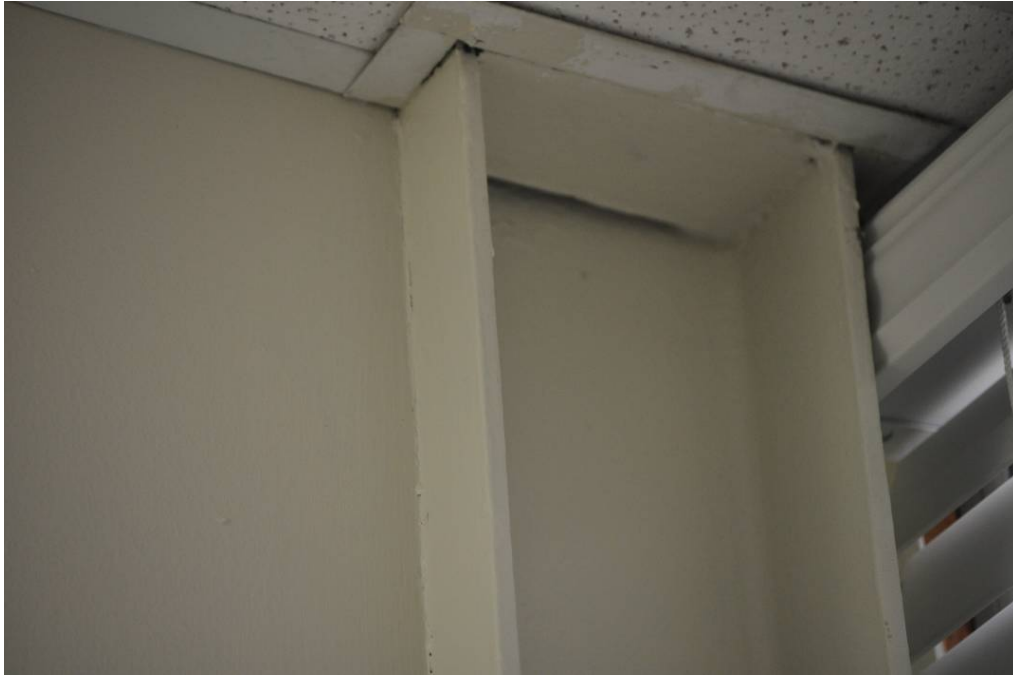
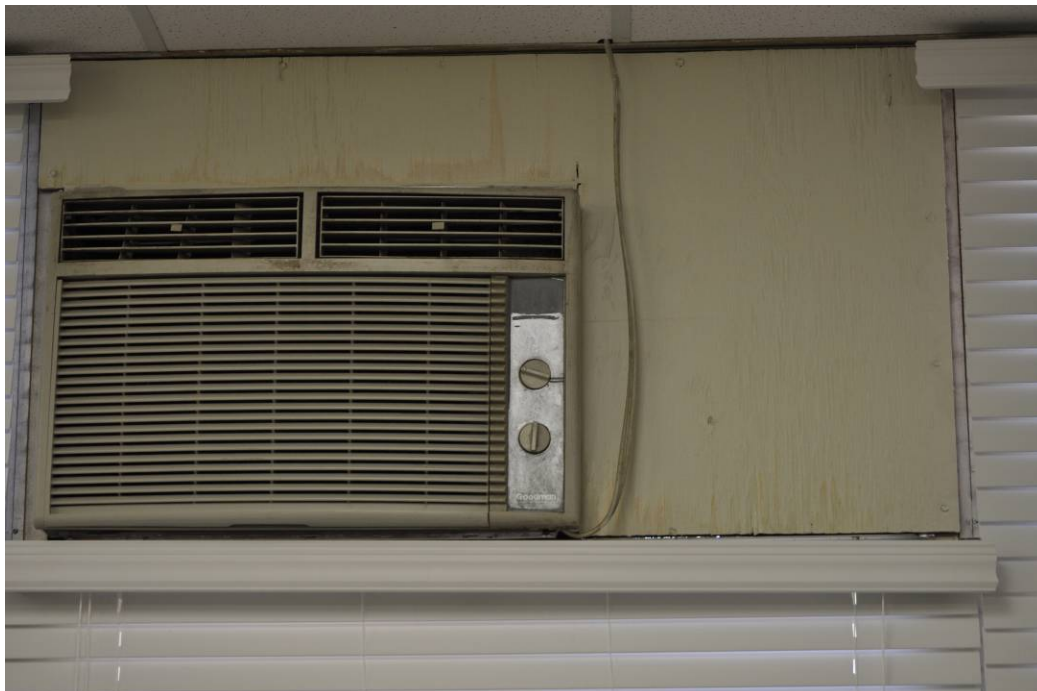
*Room 11 – Hirshfield’s Platinum Ceramic.* Room 11 showed no signs of mold or mildew other than stains found on the piece of plywood that frames a window air-conditioning unit. The stains appeared to be from exterior water intrusion. This area was specified for close monitoring during the follow-on inspections (Figure 14, Figure 15, and Figure 16).

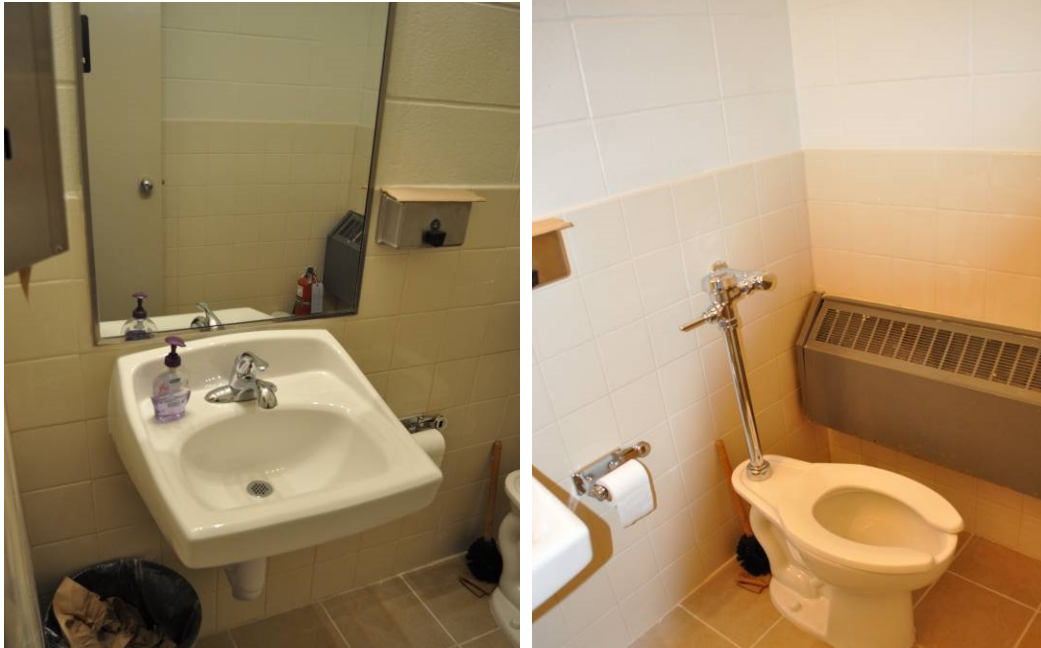
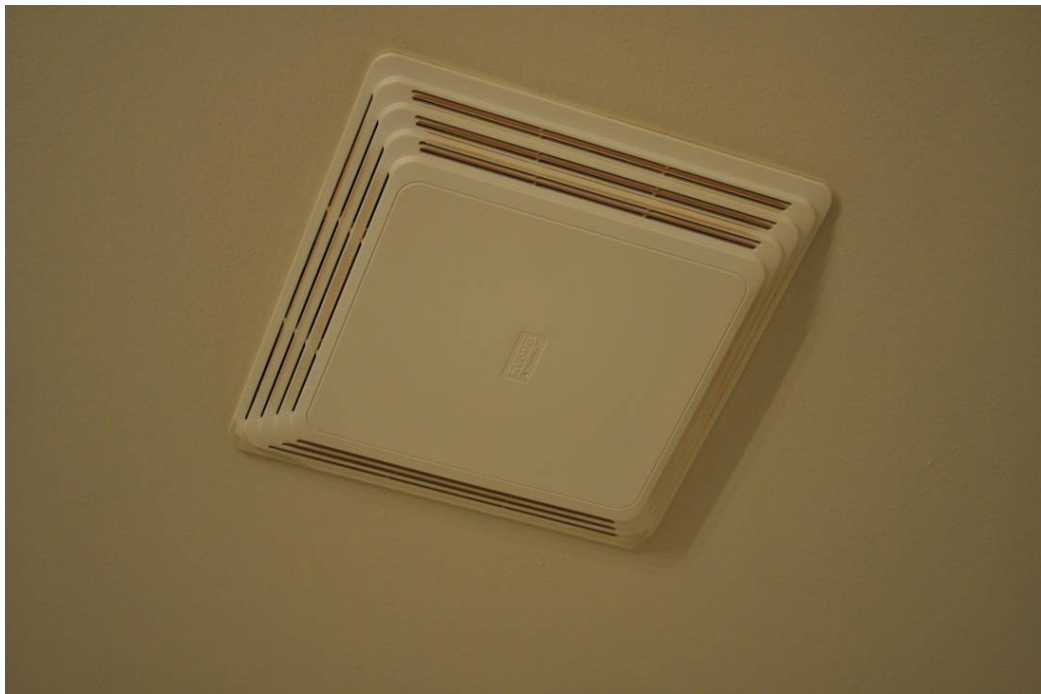
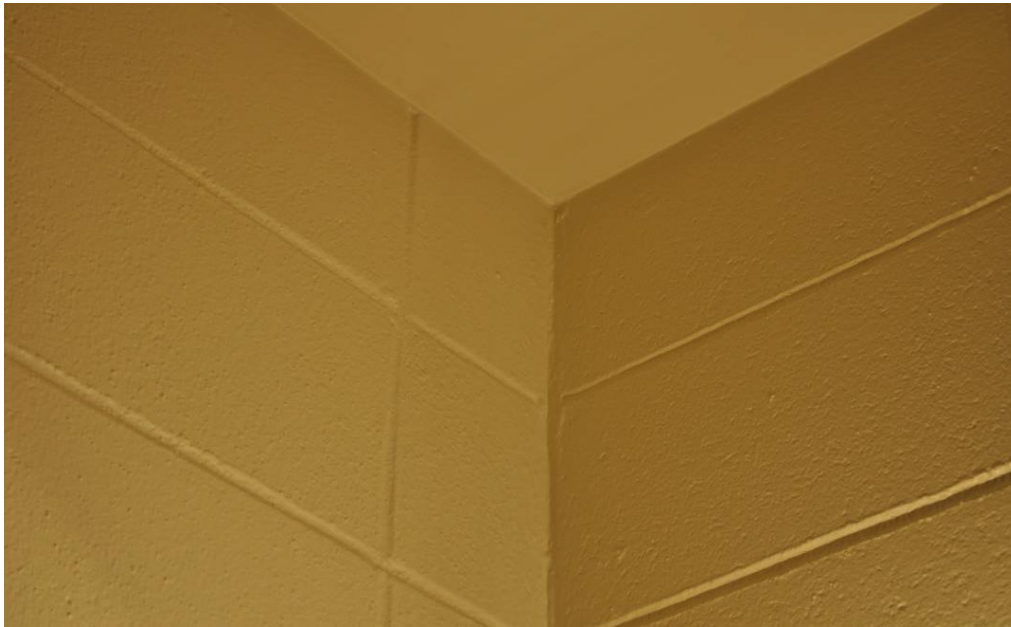
*Room 14, adjacent washroom – Sherwin William ProMar 200 (control).*  
The washroom next to Room 14 showed no signs of mold or mildew. The room was originally coated from floor to ceiling, but tile had been installed

halfway up the side walls, including around the sink and toilet areas, after coating application (Figure 17, Figure 18, and Figure 19).

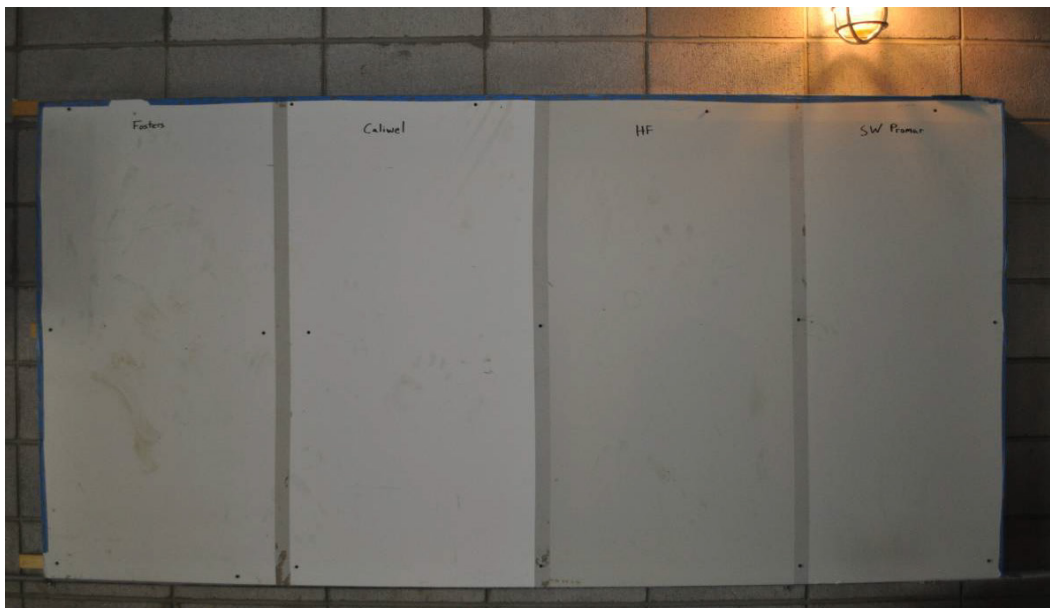
Figure 20. Test panels in the mechanical room after 8 months.

*Mechanical room test panels.* None of the test panels in the mechanical room showed any signs of mold or mildew (Figure 20). Handprints and residue had been left on the gypsum test panel. The condition inside the room continued to be less humid than previously due to refurbishment of the building.

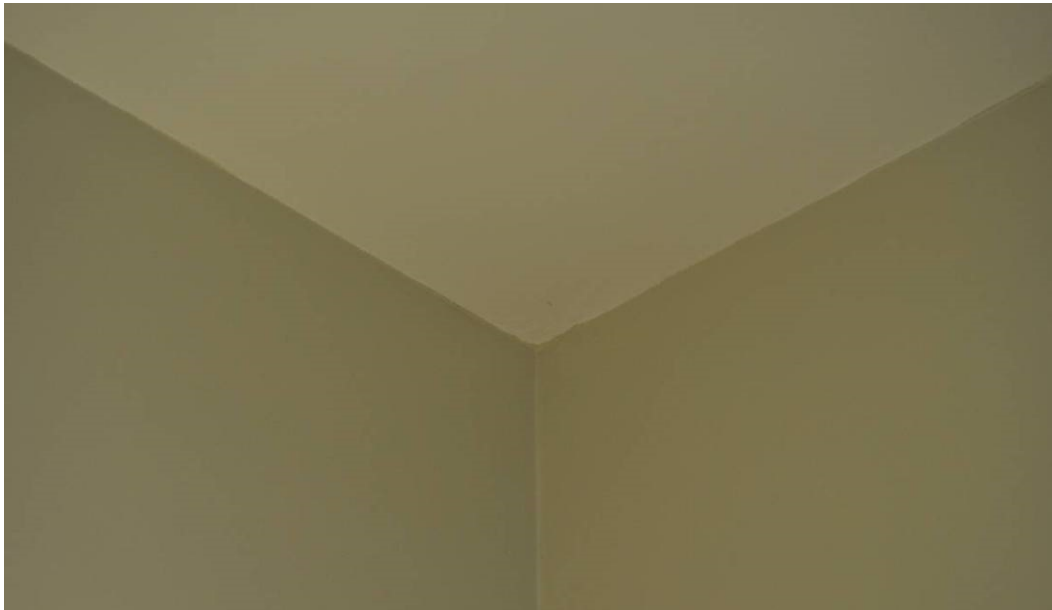
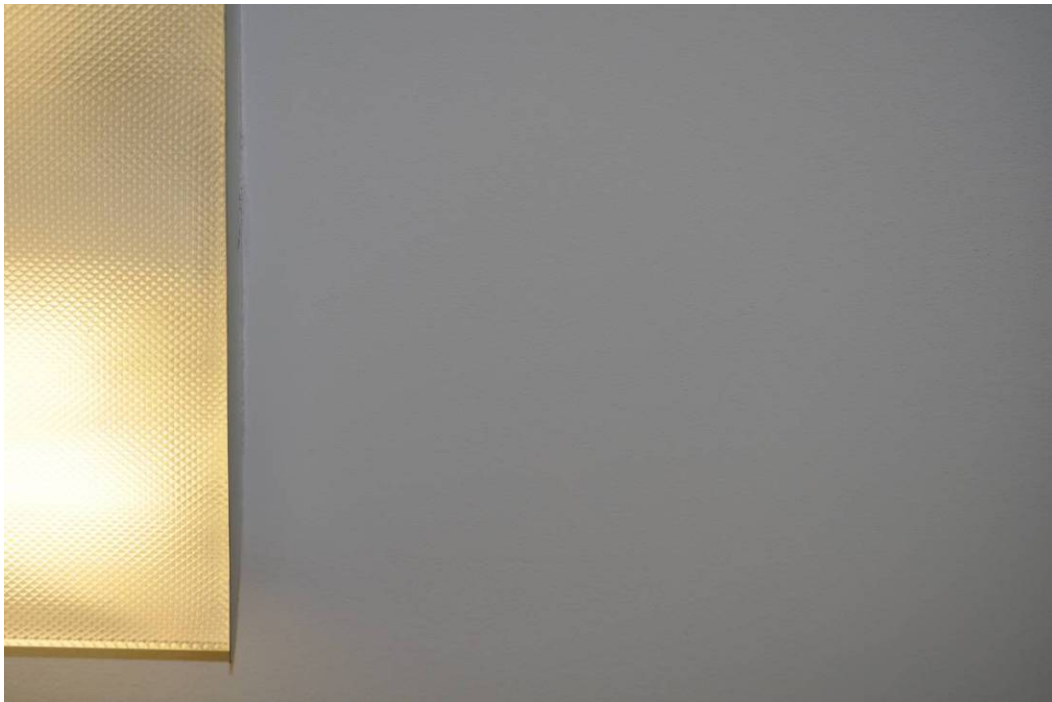
*Room 4 – Foster 40-20.* There were no signs of mold or mildew on the ceiling. The repainted walls also showed no signs of mold or mildew (Figure 21 and Figure 22).

Figure 21. Walls coated with an unknown coating and ceiling coated with Foster 40-20 in Room 4 after 8 months.

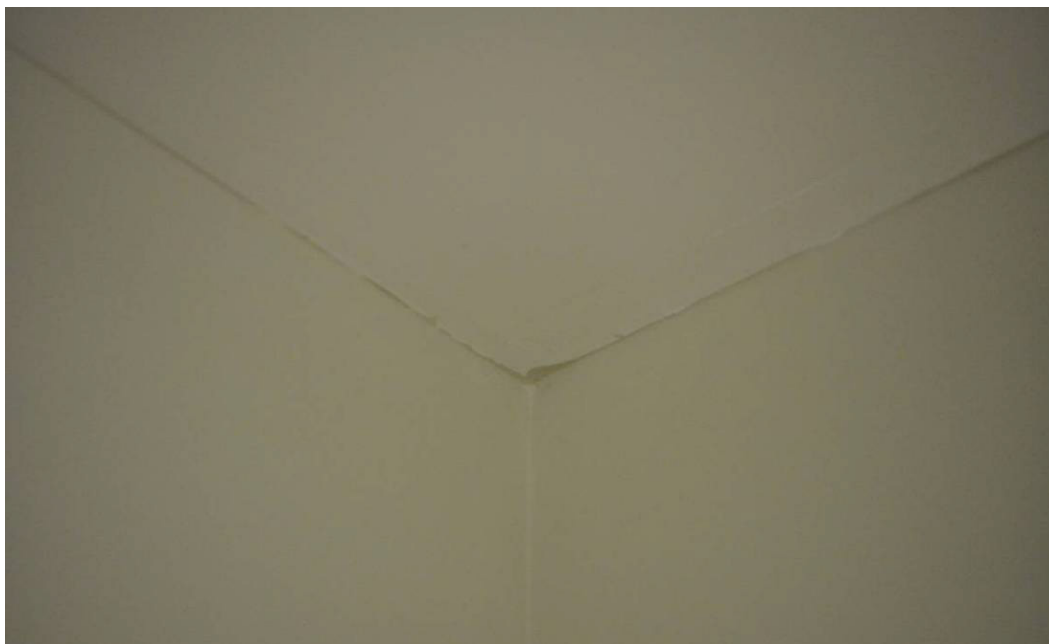
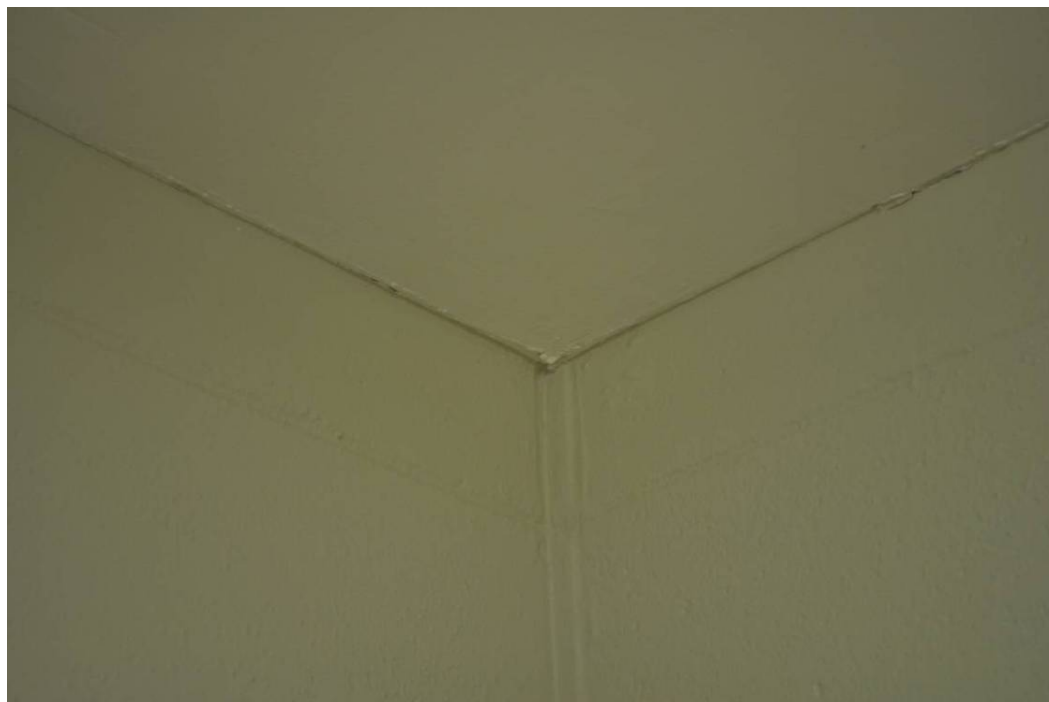
*Room 9 – Caliwel with BNA.* The demonstration coating on the ceiling showed no signs of mold or mildew (Figure 23). The repainted walls, using an unknown coating, also showed no signs of mold or mildew (Figure 24).

Figure 23. Washroom of Room 9, after 8 months, with an unknown coating on the block walls. Caliwel is still present on the ceiling.

Figure 24. Washroom of Room 9, after 8 months, with unknown coating on the block walls. Caliwel is still present on the ceiling.

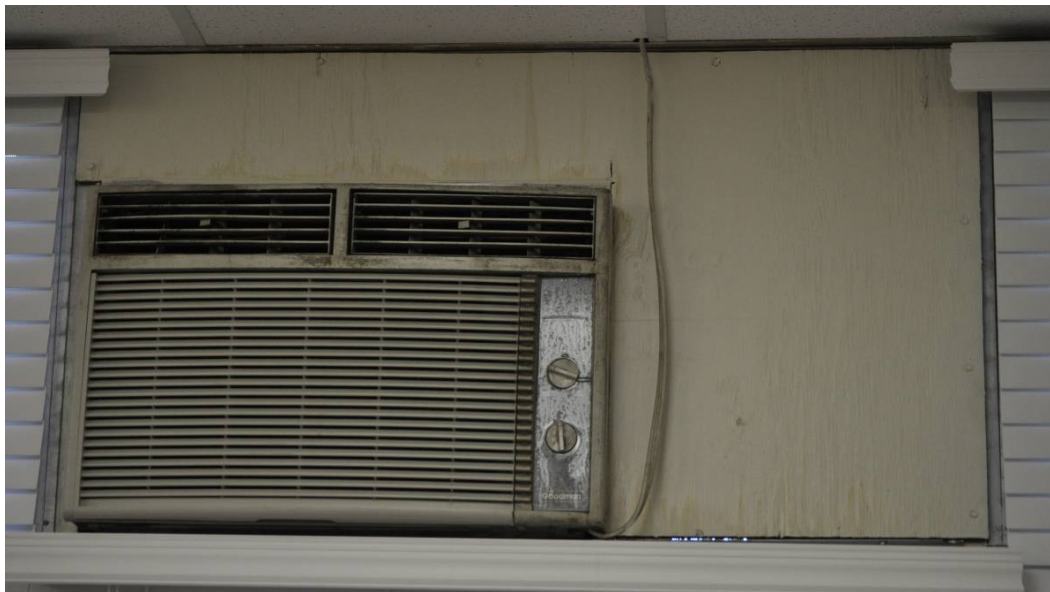
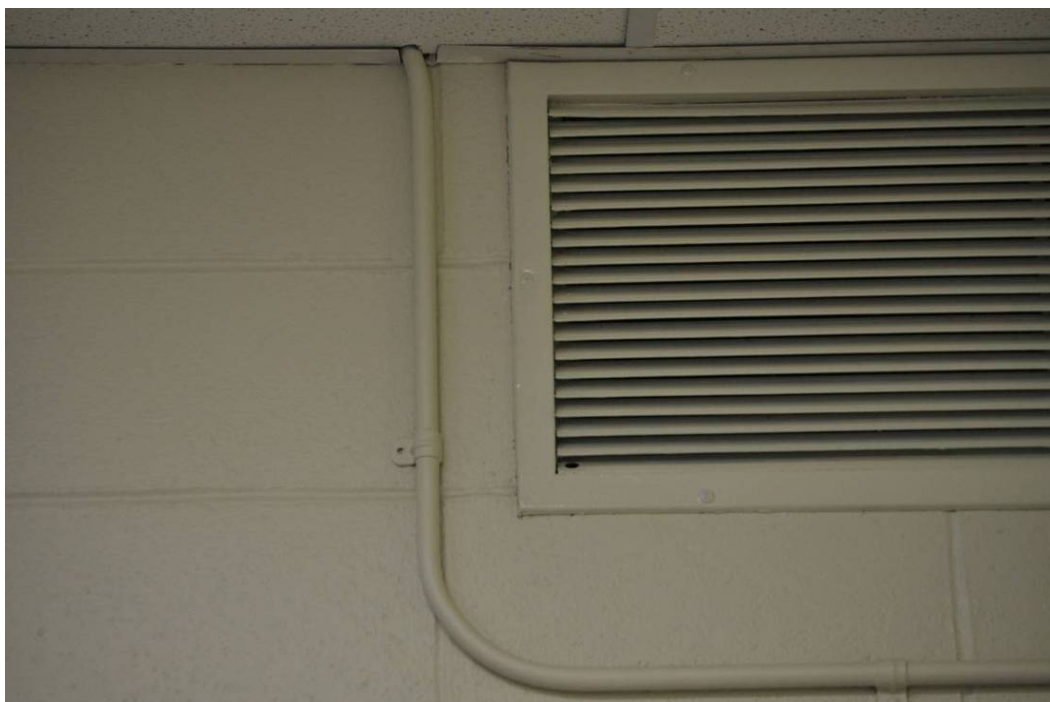
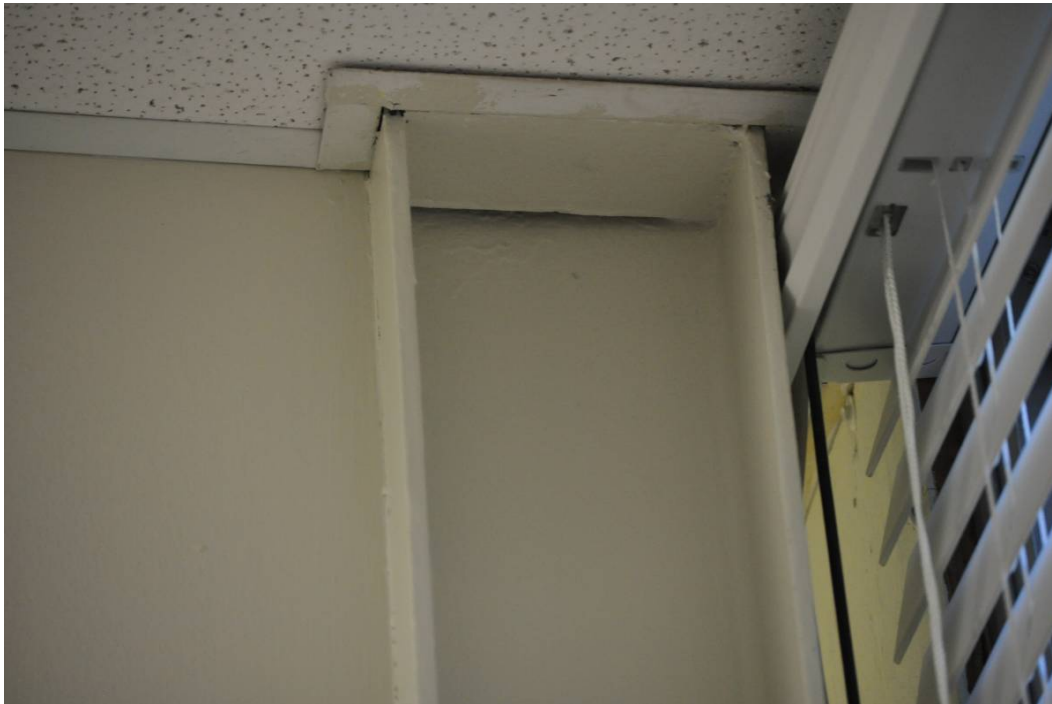
*Room 11 – Hirshfield’s Platinum Ceramic.* Room 11 showed no signs of mold or mildew other than the stains found on the piece of plywood that surrounds a window air-conditioning unit (Figure 25). The stains appeared to be from exterior water intrusion. There were no additional signs of mold or mildew since the previous inspection (Figure 26 and Figure 27).

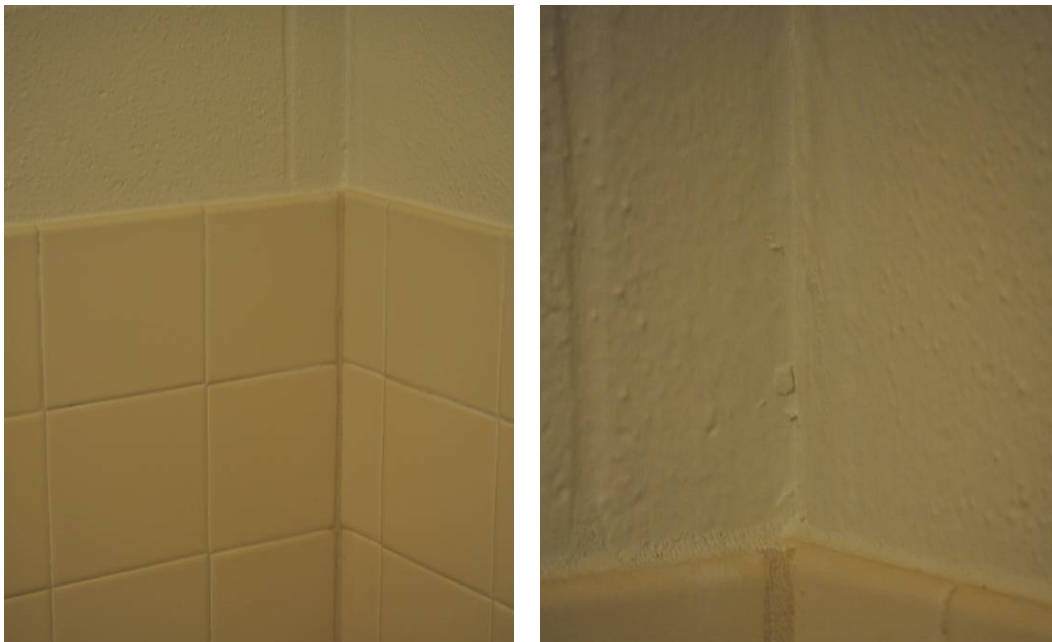
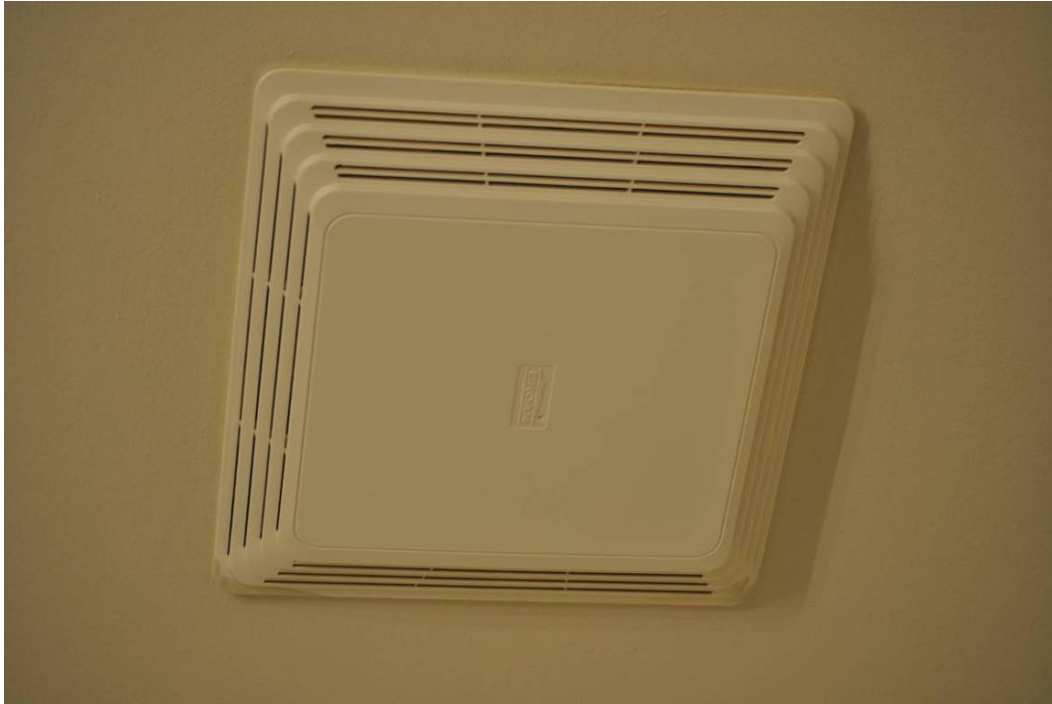
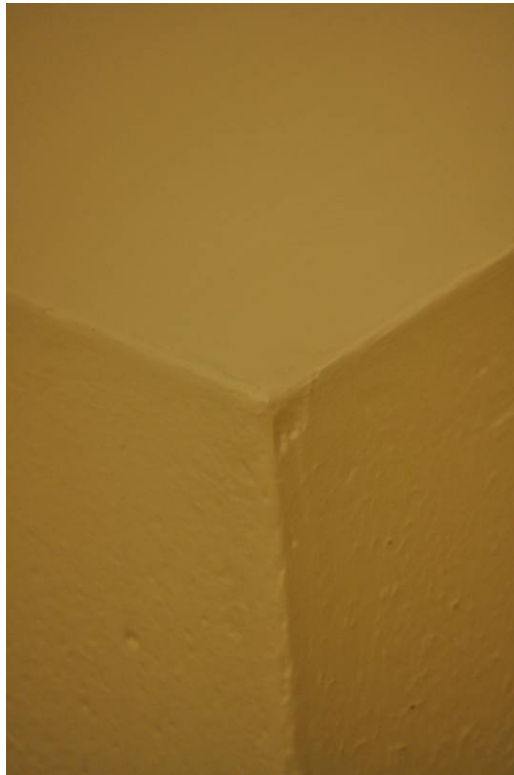
*Room 14, adjacent washroom – Sherwin William ProMar 200 (control).*  
The washroom next to Room 14 showed no signs of mold or mildew (Figure 28, Figure 29, and Figure 30).

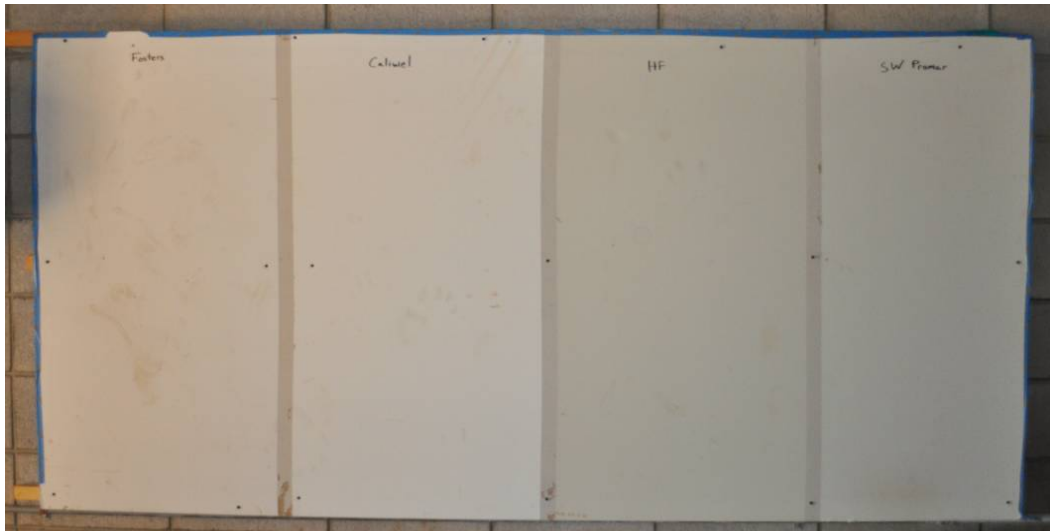
Figure 31. Test panels in the mechanical room after 12 months.

*Mechanical room test panels.* None of the test panels in the mechanical room showed any signs of mold or mildew (Figure 31). All standing water that was present in the beginning of the test period dried up and did not reoccur. Humidity remained significantly lower than before renovations.

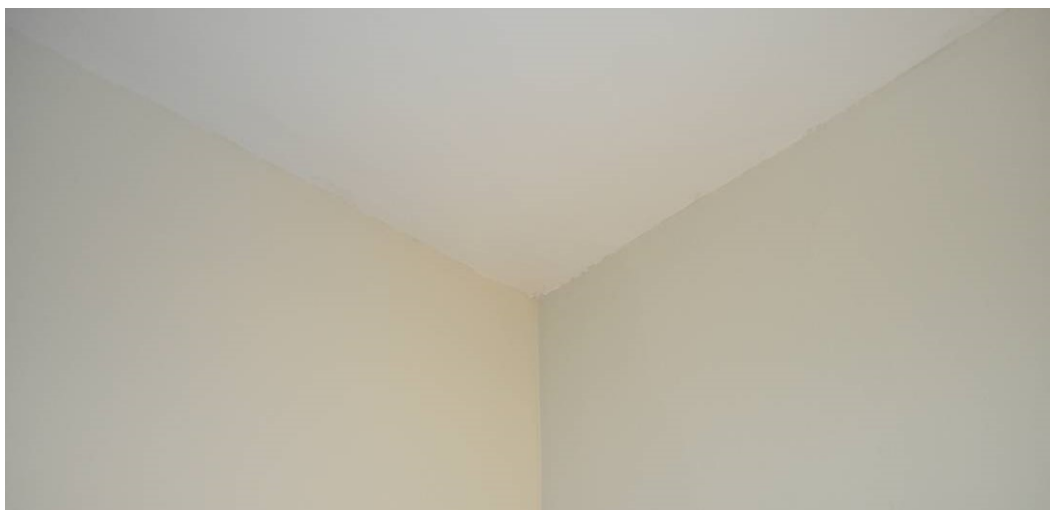
*Room 4 – Foster 40-20.* There were no signs of mold or mildew on the ceiling (Figure 32 and Figure 33). The repainted walls (coating unknown) also showed no signs of mold or mildew.

Figure 33. Vent in Room 4 after 12 months; inspector noted that no mold was present.

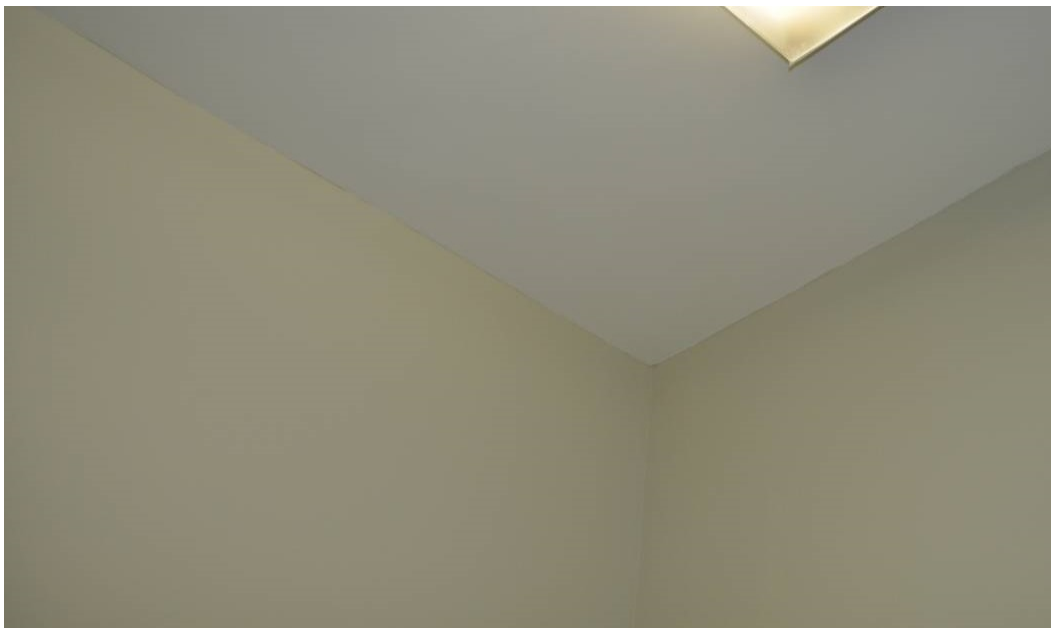
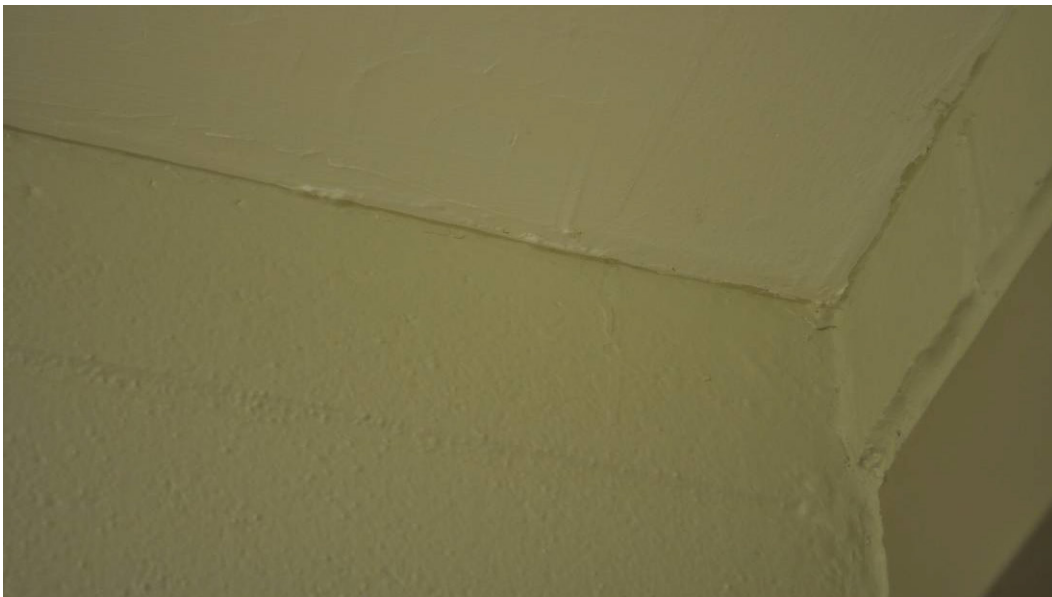
*Room 9 – Caliwel with BNA.* The ceilings continued to show no signs of mold or mildew. The repainted walls (coating unknown) also showed no signs of mold or mildew (Figure 34 and Figure 35).

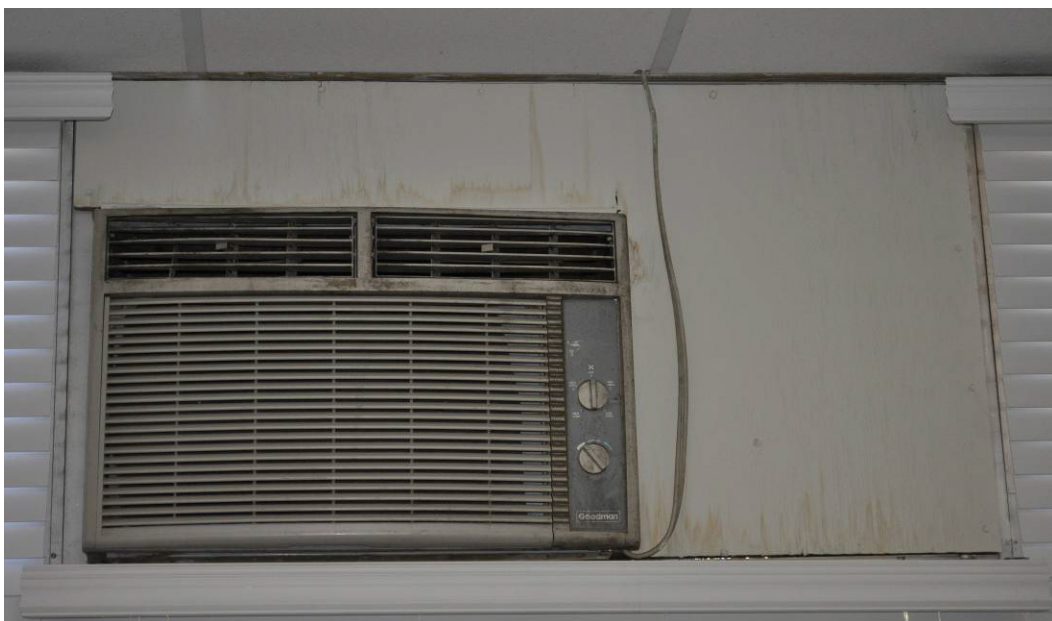
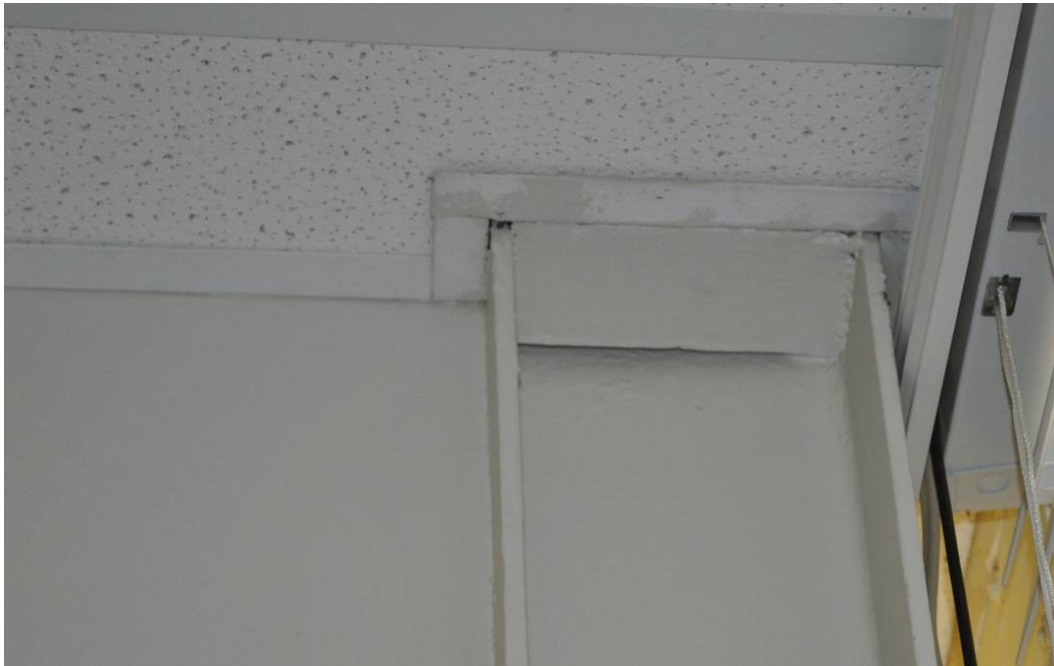
*Room 11 – Hirshfield’s Platinum Ceramic.* Room 11 showed no signs of mold or mildew other than the stains found on the piece of plywood that surrounds a window air-conditioning unit. The stains appeared to be from exterior water intrusion (Figure 36). Mostly, there appeared to be no additional signs of mold, mildew, or water intrusion from the last inspection (Figure 37). However, an HVAC vent on the interior of the room had begun to show signs of mildew, as shown in Figure 38.

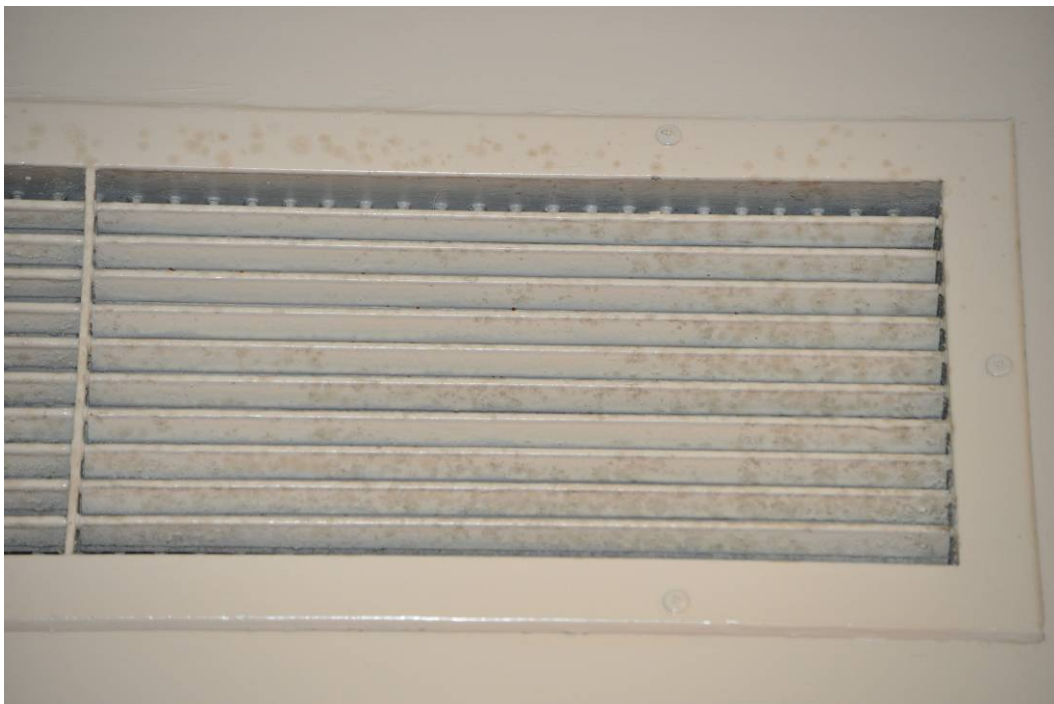
Figure 38. Air vent in Room 11, after 12 months.

**Alternative 3.** The Hirshfield's coating failed to prevent mildew growth on a metallic ceiling duct after 12 months of testing and therefore, it is not part of this analysis. This observation does not indicate a definite failure to perform, but rather, it is inconclusive because of the loss of experimental control.

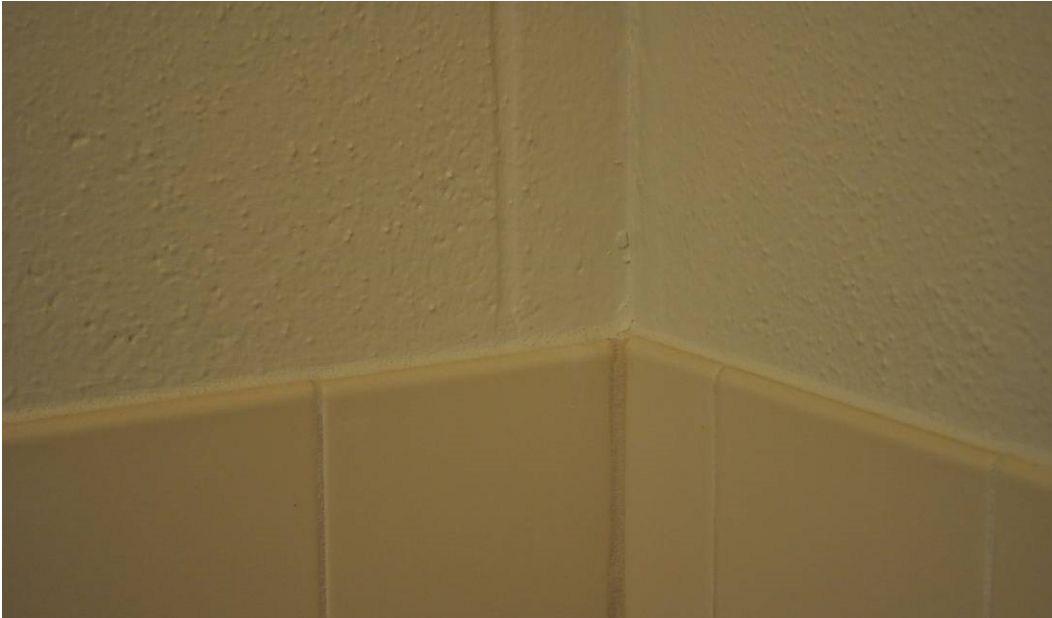
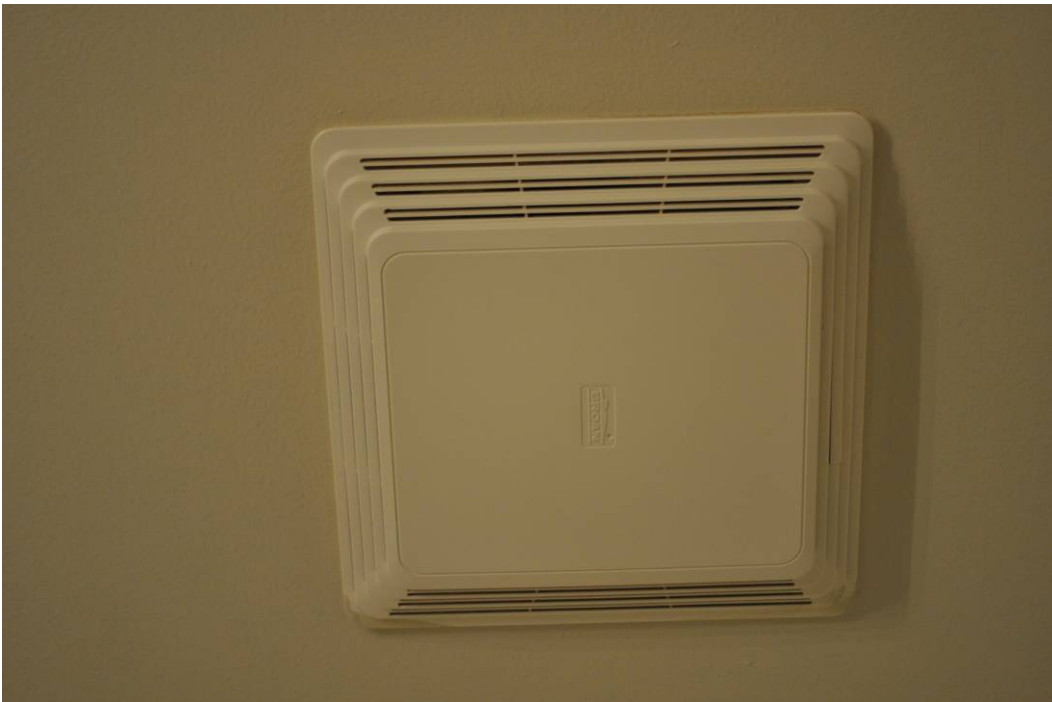
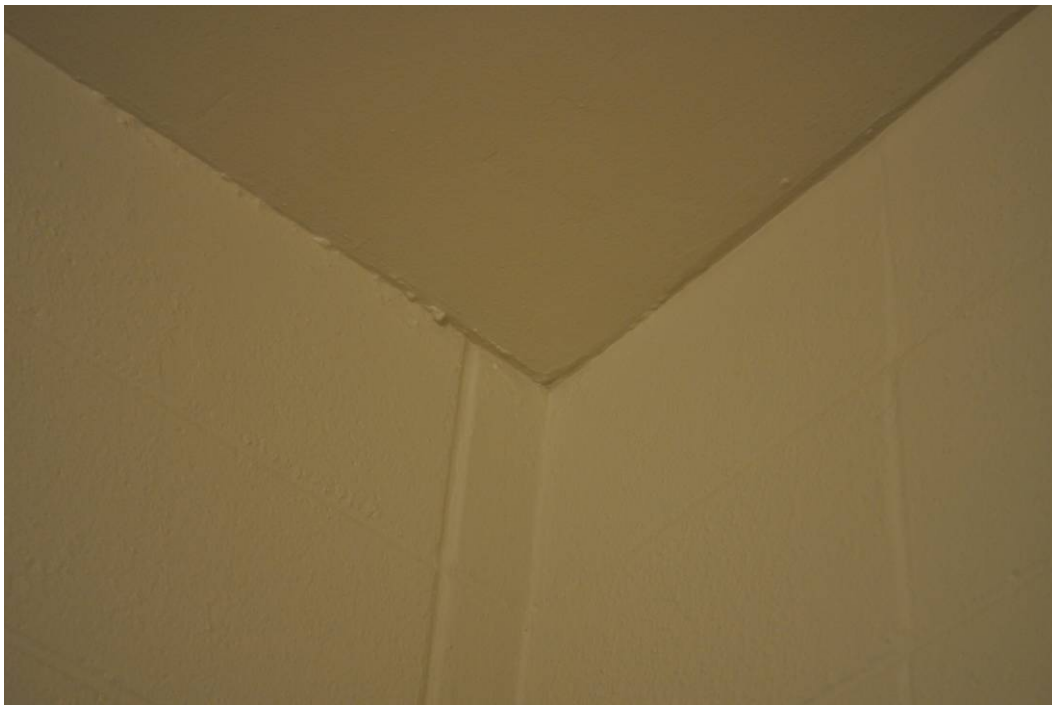
*Room 14, adjacent washroom – Sherwin William ProMar 200 (control).*  
The washroom next to Room 14 shows no signs of mold or mildew (Figure 39, Figure 40, and Figure 41).
